REPORT ON THE DERAILMENT

16th August 1953

WILNECOTE AND KINGSBURY

BRITISH RAILWAYS

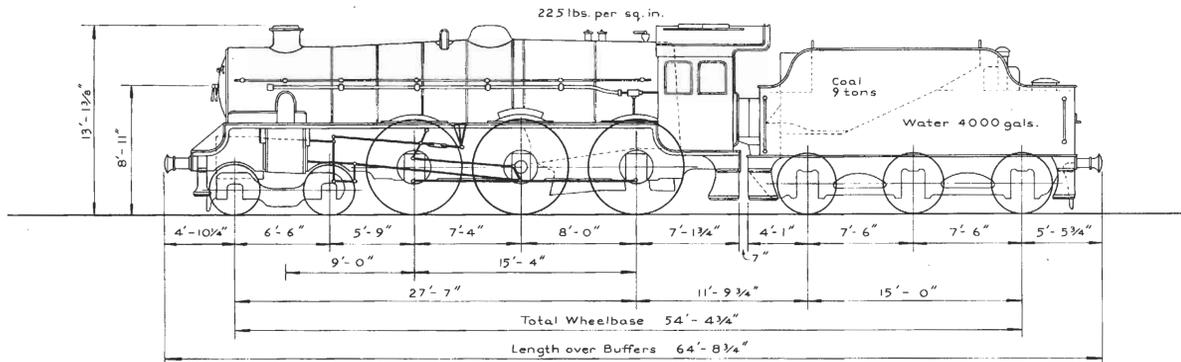
18. Important discrepancies were found in the bearing springs of the engine, and in the wheel loadings of the engine and tender. A single central laminated spring is used to transmit the weight to both the bogie axles on each side. The left hand bogie spring had three broken and three cracked plates out of 17, all old fractures, and it deflected 25% more under load than the specified amount, and 13% more than the opposite spring.

On the coupled wheels there was a maximum variation of 10% in the load deflection rate between pairs of springs. It will also be noted that the weight on the left hand driving wheel was 2 ton 1 cwt less than that on the right hand wheel, and that the weight on the right hand trailing coupled wheel was 2 tons 2 cwt less than that on its fellow, the difference being about 20% in each case. The trailing wheels of the tender were also unevenly loaded, the load on the right hand wheel being 1 ton 10 cwt less than that on the left, a difference of 25%.

51. I think that the defective bogie spring and the uneven loading of the wheels were faults which should have been checked and put right. More frequent weighing of engines may be desirable so that partially broken or weak or maladjusted springs may receive timely attention, and it might also be considered whether the tender brasses should be changed more often to prevent development of undue lateral play in the axles.

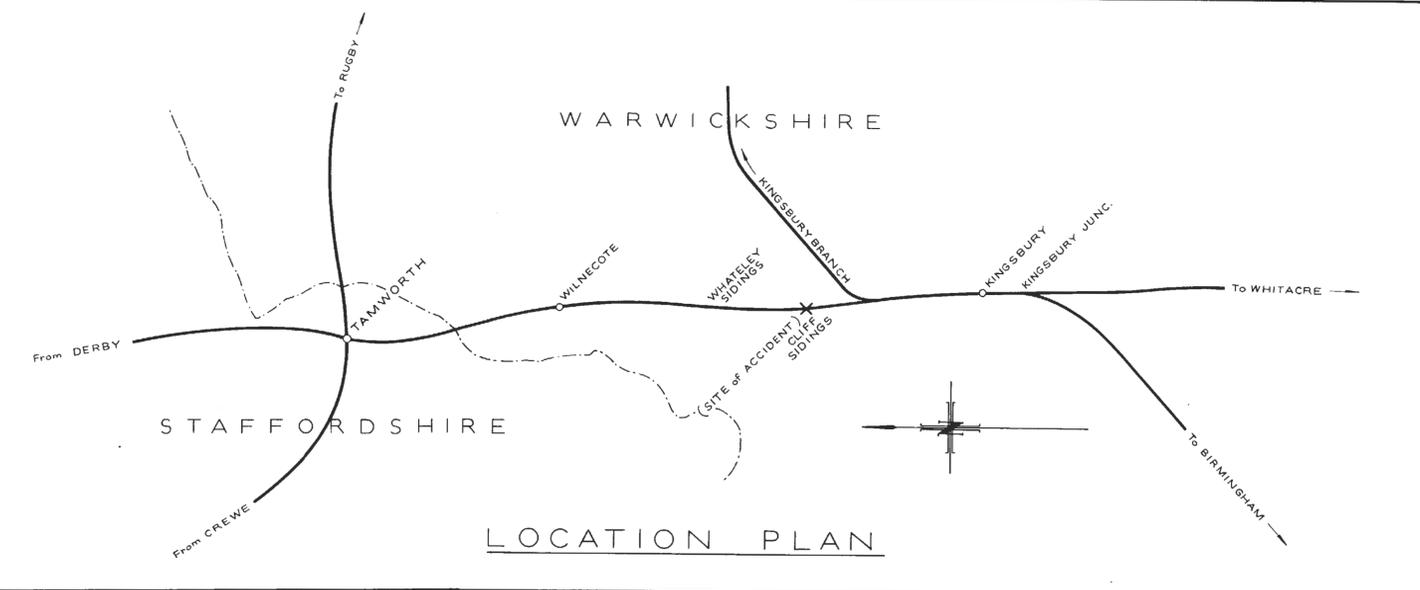
# DERAILMENT BETWEEN WILNECOTE AND KINGSBURY

25. The track showed evidence of unsteady running for some distance before the site of derailment (see drawing 3). At 100 yards past the 27th mile post the right hand rail was rubbed bright along the running edge for about 5 feet. At 133 yards the left hand rail was rubbed bright along the running edge for about 40 feet. From there up to 400 yards bright marks were visible on both rails, the length of each mark varying between 5 feet and 45 feet without any clear pattern being apparent in the relation between the marks on the two rails, though they did alternate to some extent.

The last five of these marks, none longer than 16 feet, overlapped the first two of twelve lateral distortions in the track which started at about 367 yards beyond the 27th mile post. The distortions were small, none exceeding  $\frac{1}{4}$  inch, and occurred alternately to the right and to the left of the alignment with an average pitch of about 76 feet. The distortions to the right were less than those to the left as might be expected as the resistance to lateral thrust of the ballast between the Up and Down lines would be greater than that of the ballast on the cess shoulder. The last distortion to the right was at its maximum about 23 feet before the beginning of the diagonal groove, and the last to the left about the end of the groove, the distance of this half pitch being about 50 feet, so far as could be judged owing to the damage.
