I AM directed by the Lords of the Committee of Privy Council for Trade to transmit to you to be laid before the Directors of the London and North-Western Railway Company, the enclosed copy of the report made by Captain Tyler, R.E., the officer appointed by their Lordships to inquire into the circumstances connected with the accident which occurred on the 11th June from a goods train breaking through a bridge near Wootton.

honour to report, for the information of the Lords of the Committee of Privy Council for Trade, the result of my inquiry into the circumstances which attended the accident, that occurred on the 11th of that month, in consequence of the failure of a bridge on the London and North-Western Railway between Leamington and Kenilworth.

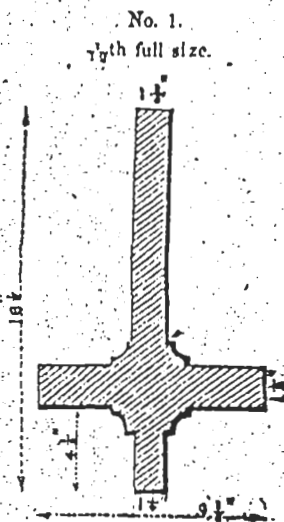
namely, that from Stoneleigh to Guy's Cliff, and that from Leek Wootton to Hill Wootton; and it covered a span of 50 feet. The main girders, consisting of two timber trusses, were connected together below by five cast-iron transverse girders (of the section No. 1. in the margin); and these latter were suspended at their ends on wrought-iron bolts attached to the trusses. The rails were carried on longitudinal sleepers, resting on planking, which covered both the cast-iron cross-girders and the longitudinal baulks of timber under the planking which were supported by them.

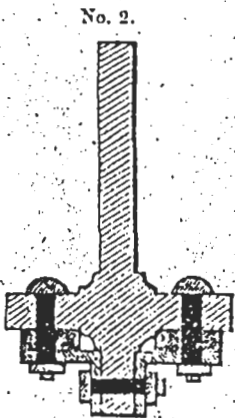
Bolt-hole $\frac{3}{4}''$ in diameter.

In the year 1853, the trusses of the main girders were strengthened, some of the timbers were renewed, new rails were placed upon the bridge, and one of the cast-iron cross-girders was patched, to cover a defect which appeared, below the flange, and near the middle of it, at the point where the strains upon it in tension were greatest.

It was spliced, as shown in section No. 2. in the margin, with two angle irons, each $3\frac{1}{2}'' \times 3\frac{1}{2}'' \times \frac{1}{2}''$, by 3 feet long, and two packing strips, $1'' \times 2\frac{1}{2}''$ by the same length, and was pierced by bolt holes (shown in black in the section), on each side of the flange, and below it; those through the web having been six in number.

But the second girder above referred to, was weakened most materially, when it was patched in 1853, by the holes (at the ends of the splices) that were made in its flange, and through the lower portion of its middle web; and it was afterwards still further reduced in strength by the crack, connected with the bolt-hole next to the west end of the splice, which was the immediate cause of its failure.

These girders were of a defective form, inasmuch as the flange should have been at the bottom of them, instead of at $4\frac{1}{2}''$ from it; but they were constructed at a time when these matters were not so well understood as at present. They were of ample strength for the engines then in use, but they did not afford a sufficient margin of strength for the much heavier engines of the present day. The application of the splice upon the second of them in 1853, was an improper proceeding, as it was likely to lead to its ultimate failure, by weakening it at the bolt-holes near each end of the splice, and by the extra stiffness produced in the part spliced, which would tend to bring increased strains upon the portions near to those at each end of it which were thus weakened.

Instead of splicing that defective girder at that time, it would have been better to have taken out all the five girders, and to have substituted in their places new transverse girders of a better description and more suitable material.
